EVALUATION OF STREAM IMPROVEMENT STRUCTURES
PROGRESS REPORT 1963: FIRST YEAR

UNITED STATES DEPARTMENT OF AGRICULTURE
FOREST SERVICE

H. J. McKirdy
Fishery Biologist

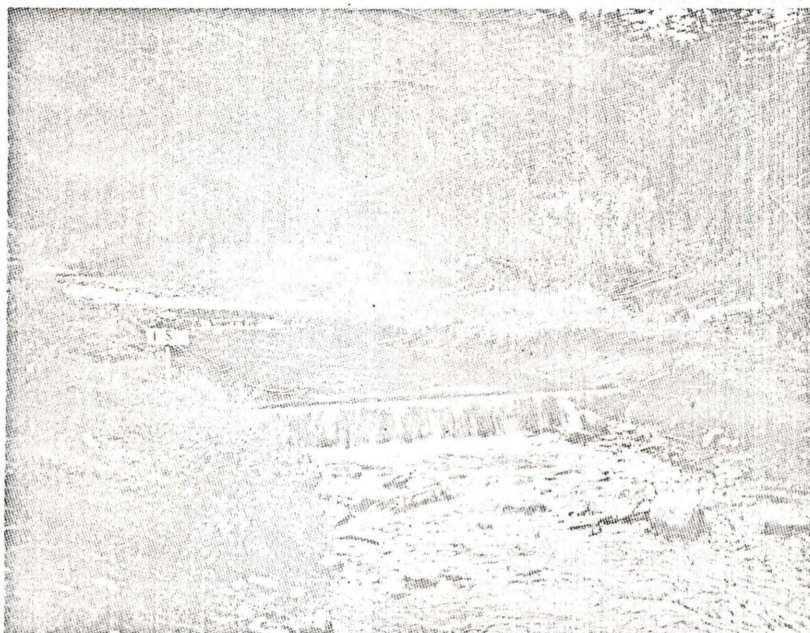
Rio Pueblo Site 1-S

4. Site 1-S - Stream flow less. Too early for conclusions.
5. Site 2-S - Very good pools on right side. Looks good.
6. Site 3-S - Pool area over 15 inches deep. Looks good.

CONDITION OF STRUCTURE: Good

TYPE OF STRUCTURE: Single Log EVALUATION SITE #: 1-S

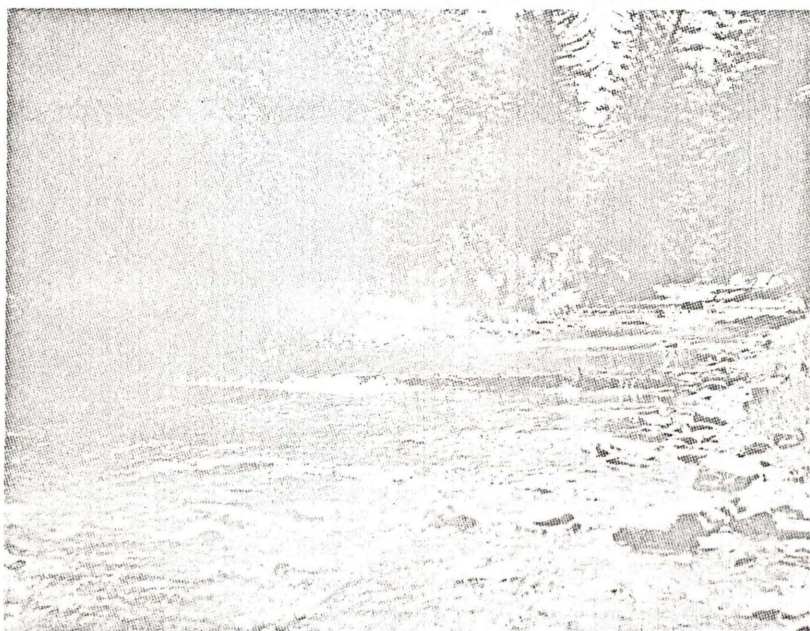
Rio Pueblo Site 2-S

CONDITION OF STRUCTURE: Good

TYPE OF STRUCTURE: Trash Catcher EVALUATION SITE #: 2-S

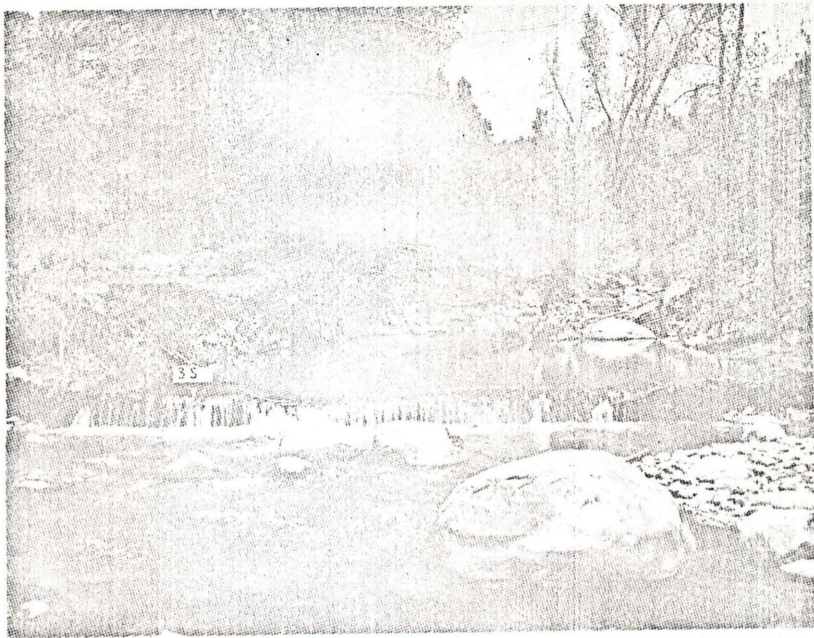
El Rito Site 3-S

CONDITION OF STRUCTURE: Very Good

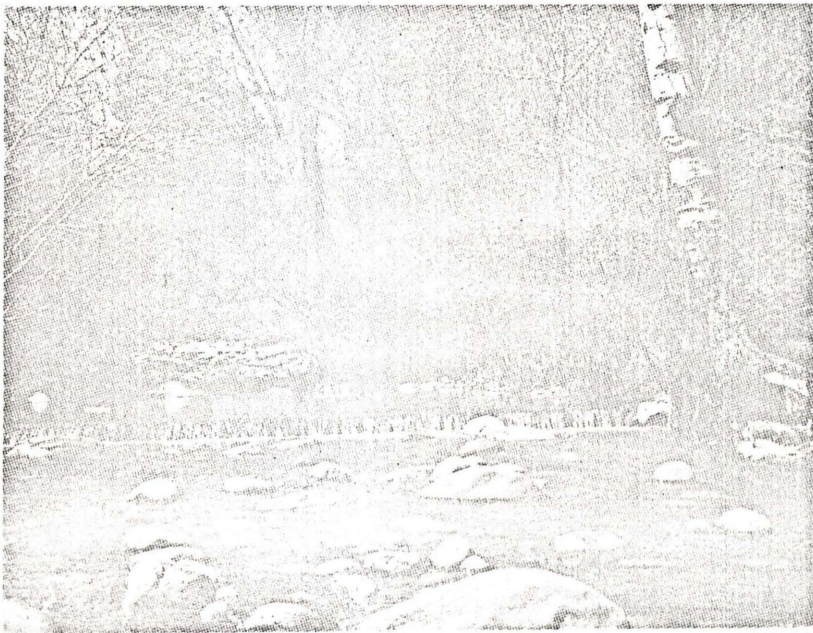
El Rito Site 4-S

7. Site 4-S - Same as 3-S.
8. Site 5-S - Silt condition above, nice pool forming below. (This stream not stocked prior to improvement.)
9. Site 6-S - Same conditions as 5-S but not completely sealed as yet.

CONDITION OF STRUCTURE: Very Good

TYPE OF STRUCTURE: Trash Catcher EVALUATION SITE #: 4-S

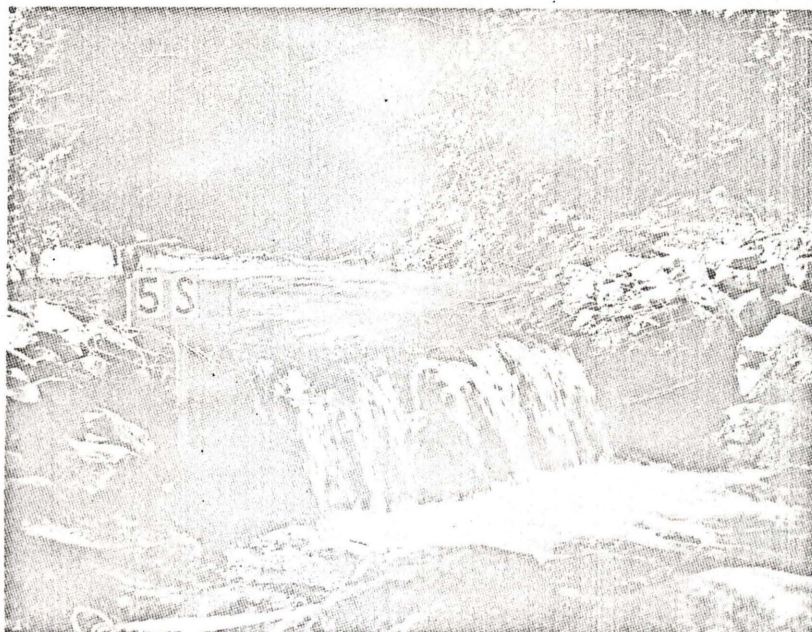
Las Huertas Site #5-S

CONDITION OF STRUCTURE: Good

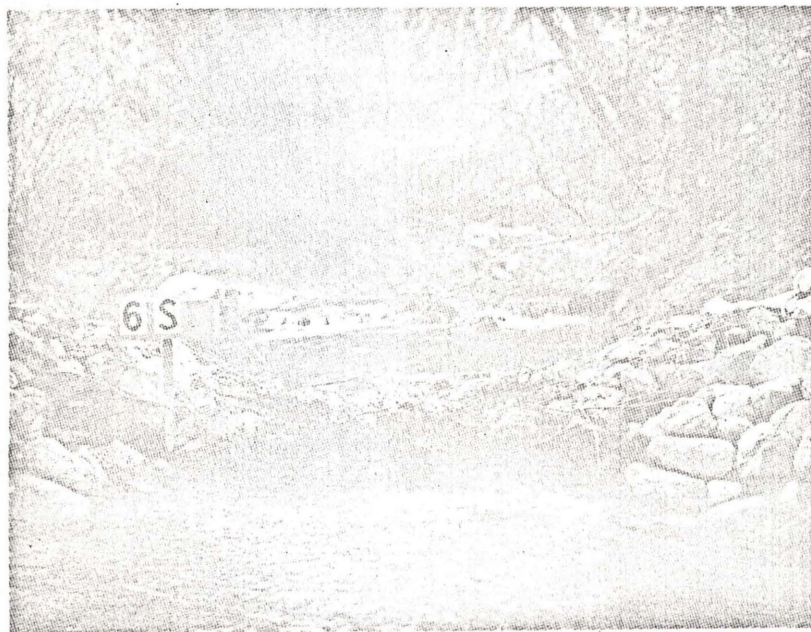
Las Huertas Site #6-S

CONDITION OF STRUCTURE: Good

TYPE OF STRUCTURE: Gabion EVALUATION SITE #: 6-S

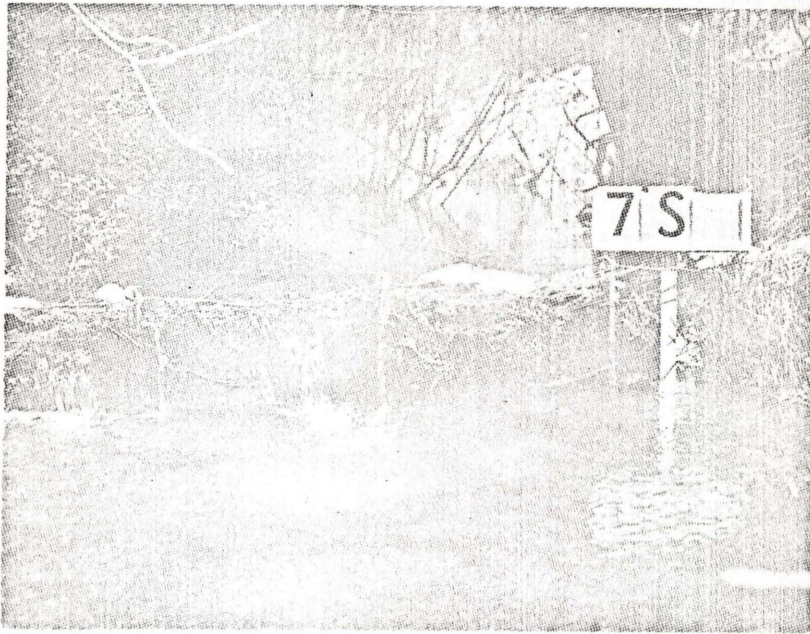
Tajique Creek Site #7-8

10. Site 7-S - Silt conditions above, forming nice pools below. (This stream had no fishery prior to installation of structures.) Trash catcher not sealing too well, water inflow practically non-existent during dry part of the year. Control site was completely dried up during October.

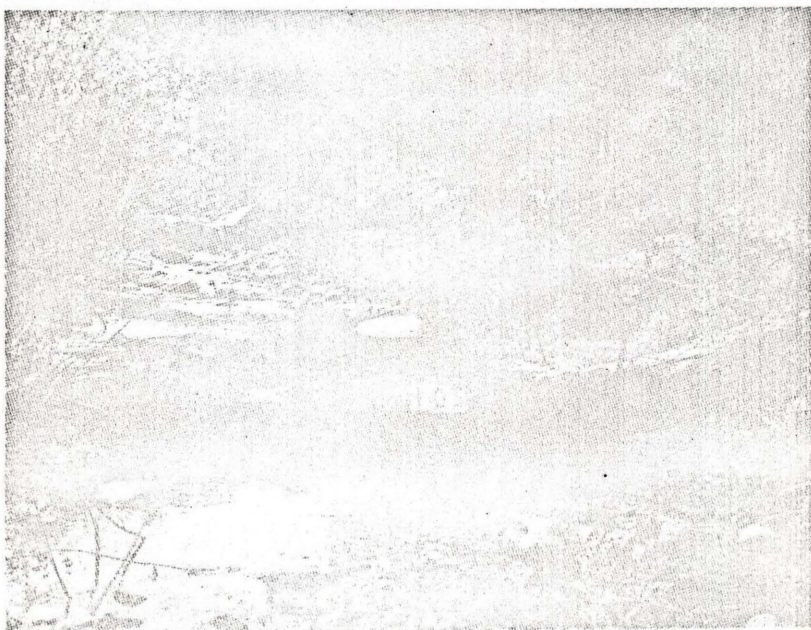
So. Fork Bonito Site #10-S

13. Site 10-S - Trash catcher not catching too well at present. Very little silt with a pool forming above.
14. Site 11-S - Very fine pools forming below. Plastic liner working well.

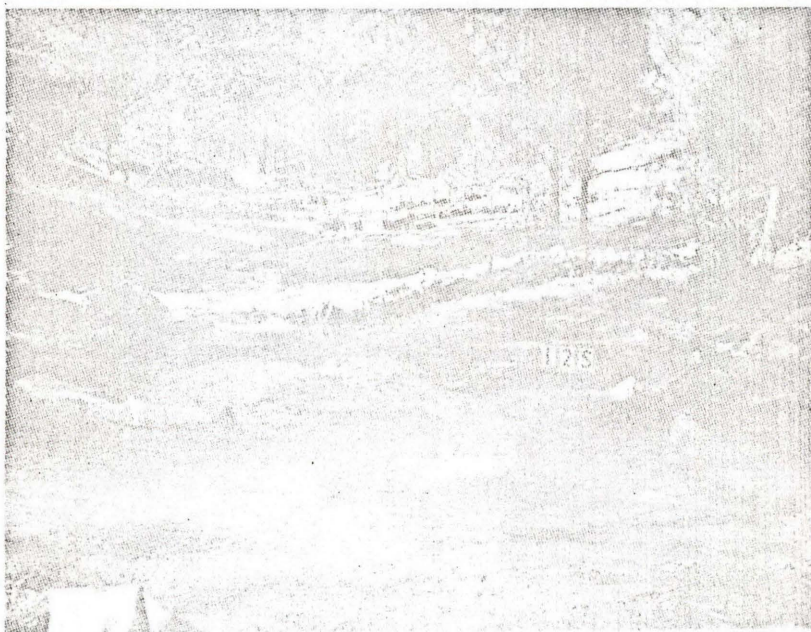
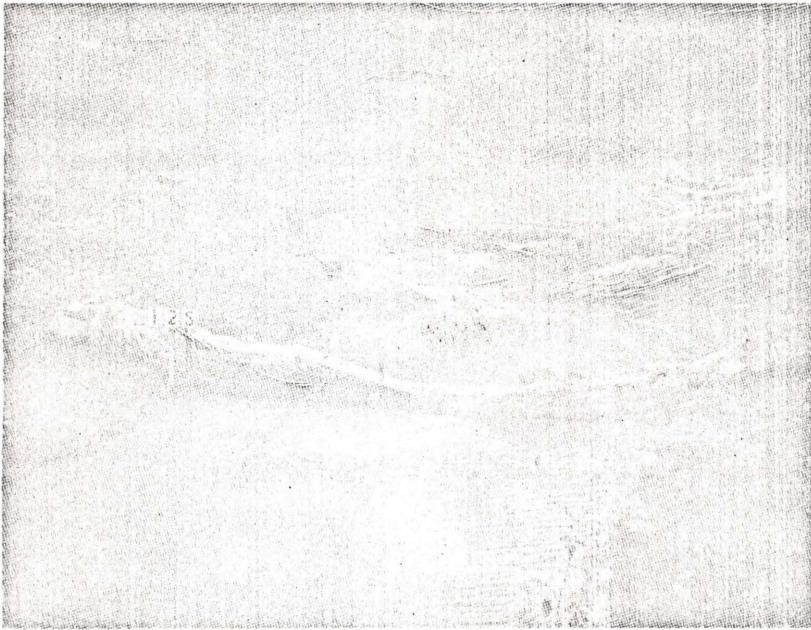
Eagle Creek Site #12-8 (Oct.)
(See next sheet for Aug. photo)

15. Site 12-S - Two photos are shown for comparison purposes. The October photo shows the site after heavy rains washed silt in from a new road built above the area. Very little, if any benefit will be derived from this portion of stream. The upper portion (Site 11-S and 6-C) was not affected by this road. The August photo shows nice pools before rains came. Structures are all brand new.

Eagle Creek Site #12-S (Aug.)
Compare depth measurements for
same site on prior sheet.

Additional Sheet for 12-S
(Road building results)
Depth measurements only

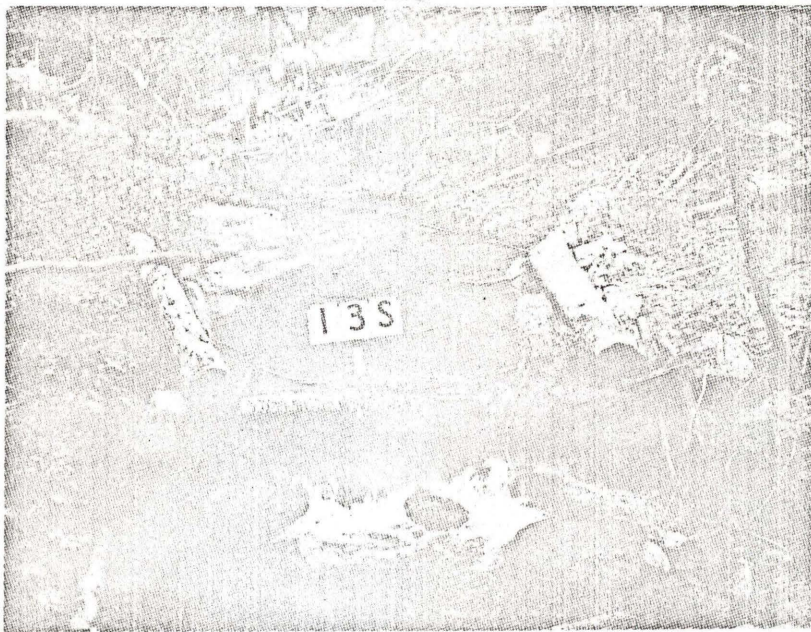
Rio En Medio Site #13-S

16. Site 13-S - Silting on top, nice pool below.
17. Site 14-S - Working well at present. Water flow slowed down considerably, however, temperatures about the same.

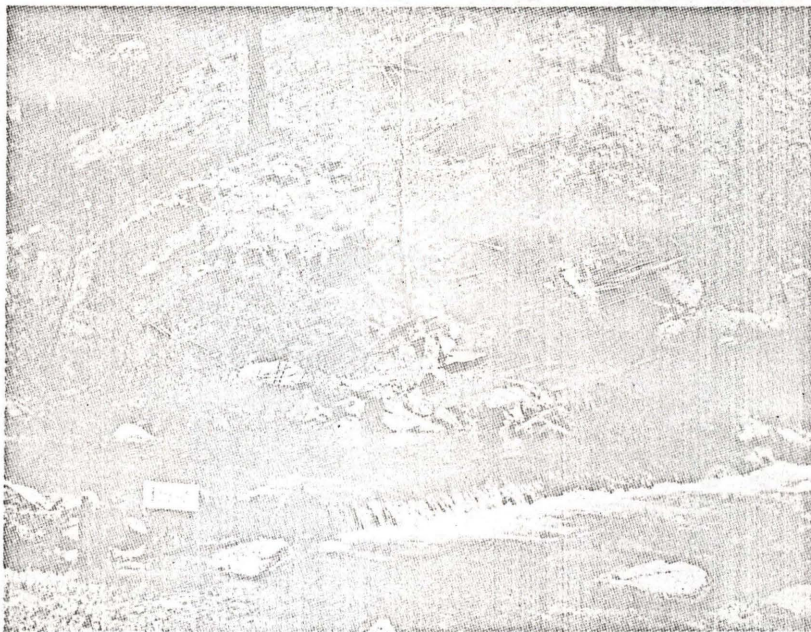
Rio Las Vacas Site #15-S

18. Site 15-S - Very little silt, deep pool above. Structure working well.
19. Site 16-S - Silting in on top. This is also a trash catcher type. Presently looks good.
